Quest Engineering & Failure Analysis, Inc.
www.quest-engineering.com

October 12, 2023

Re: FR26 Report

File: Bryson Accident
Quest No: 10519

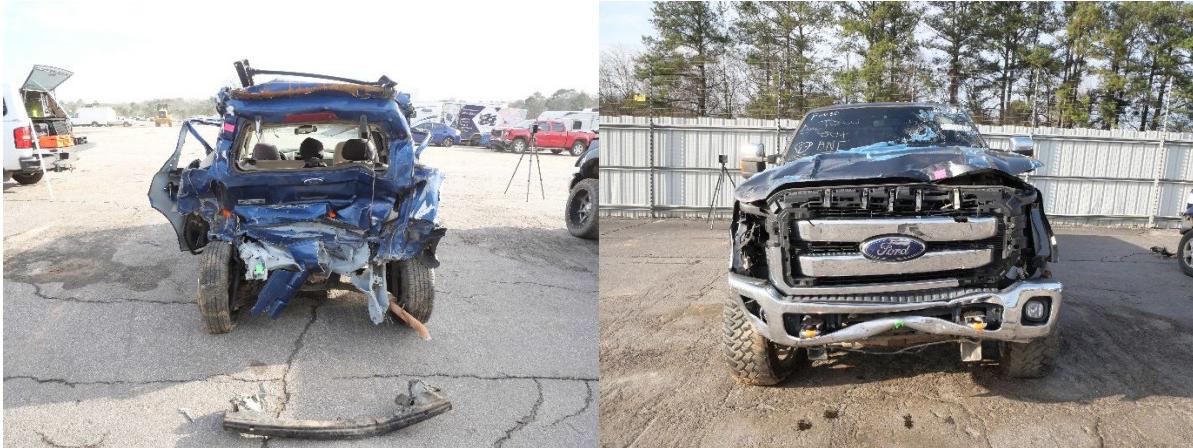
Figure 1: Match points with brightly colored tape

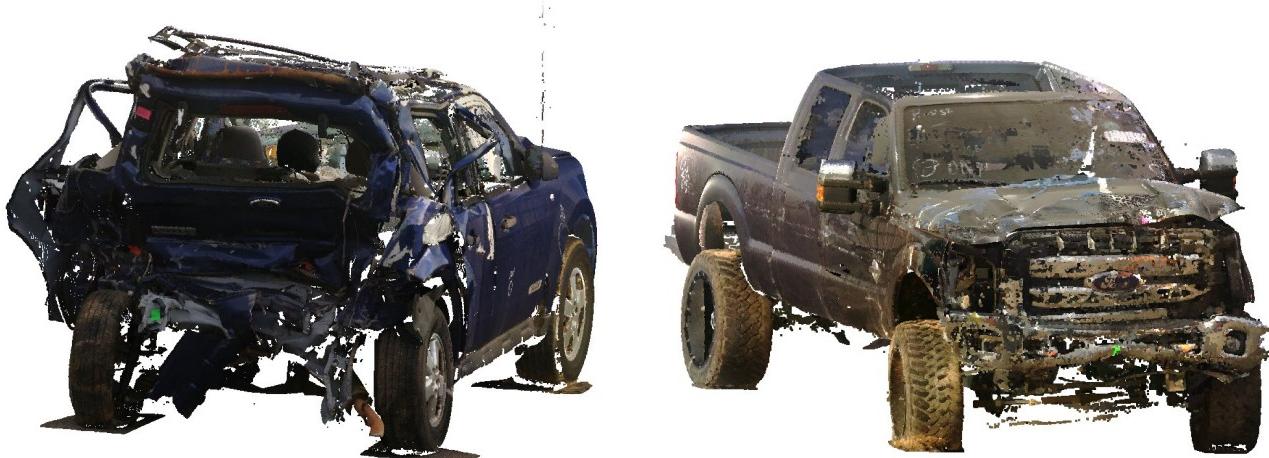
Figure 2: Brightly colored tape visible on the point cloud models
